**Flood Control Project Maintenance  
Levee Inspections**

## Maintenance Issue Types Only, Levee Inspection Report By Mile - Spring 2019

### Reclamation District No. 2091 Chase

Waterway	Bank	Unit Miles	Inspection Start/End	Inspector
Unit No. 01 San Joaquin River	Right	7.46	04/03/2019 04/03/2019	Corey Fujitani

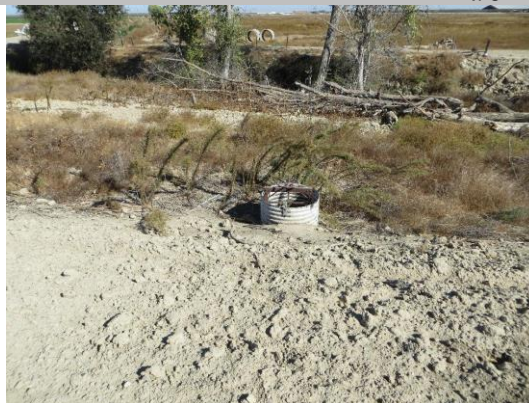
Photo 1 of 3 : UCIP\_SP\_2019\_43207\_38148.jpg

Comment Code					
Inspector Comment					
FS_ID:43207					
DS_ID:23155					
EP_NO: N/A					
Repair Type: Non-Urgent					
Crossing Status: Found					
UCIP Comments: 10/15/2013 Appears abandoned and if so should be done so properly. (W. Wylie - DWR UCIP)					
FIELD_STRUCT_DESC: *ABANDONED* 24-inch corrugated metal drainage pipe through the levee, 7.2 feet below the crown. Slide gate in a 36-inch corrugated metal pipe (CMP) riser on the waterside (WS) slope. [Additional Reference(s): DWR Levee Log, 1992. USACE San Joaquin O&M Manual 6, September 1961, (HLM 0.07), Drawing No. 07-04-1555, Sheets 1555/17 and 1555/55, (Station 906+85)].					
FS Date: 1/29/2015 2:26:31 PM

Slide gate in 36-inch CMP riser on WS toe.

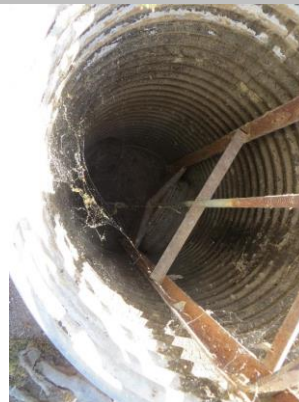
Photo 2 of 3 : UCIP\_SP\_2019\_43207\_38147.jpg

Slide gate in 36-inch CMP riser on WS toe.

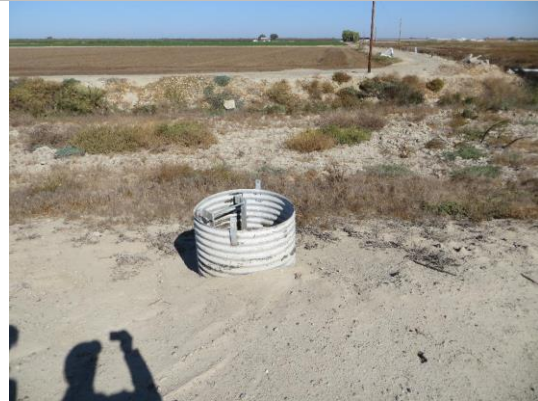
Photo 1 of 3 : UCIP\_SP\_2019\_53094\_38150.jpg

Comment Code						
Inspector Comment						
FS_ID:53094 DS_ID:23156 EP_NO: N/A Repair Type: Non-Urgent Crossing Status: Found UCIP Comments: 10/18/2018 Crossing remains abandoned. Unable to locate WS outlet due to dense vegetation. Crossing has been downgraded from Urgent to Non-Urgent. No integrity issues were observed along pipe alignment. LMA is still seeking proper abandonment or removal of this crossing. Crossing is part of the Deferred Maintenance Project (DMP) phase 1 inspection. No video inspection has been completed yet. (O. Magana - DWR UCIP) 11/18/2016 Same as last inspection this is a non-functional crossing with no visible inlet on LS or outlet on WS. The only appurtenance found at this location is a CMP riser with a missing cover located on the WS. This crossing remains Urgent since the pipe on the WS may still be opened. According to Mike Alves, this crossing is abandoned and the City of Modesto is working with CVFPB to authorize proper abandonment/removal. The City is working at finding funds to pay for proper abandonment/removal of all the drainage structures through this levee. (O. Magana - DWR UCIP)10/15/2013 Pipe open on WS and slide gate has been removed. Appears abandoned and should be done so properly. (W. Wylie - City of Modesto) FIELD_STRUCT_DESC: *ABANDONED* 24-inch corrugated metal drainage pipe through the levee, 9 feet below the crown. Slide gate in a corrugated metal pipe (CMP) riser located on the waterside (WS) slope. [Additional Reference(s): DWR Levee Log, 1992. USACE San Joaquin O&M Manual 6, September 1961, (HLM 0.10), Drawing No. 07-04-1555, Sheets 1555/17 and 1555/55, (Station 907+55)]. FS Date: 10/18/2018

36-inch CMP riser on WS slope.

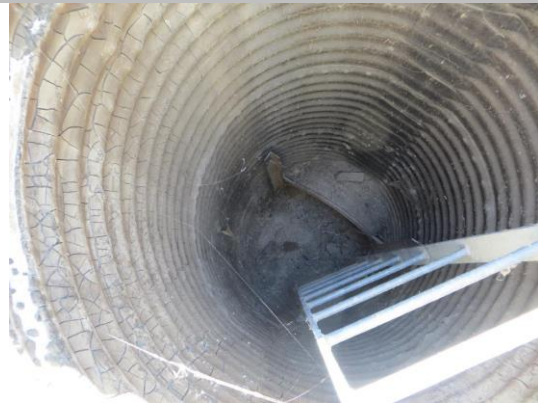
Photo 2 of 3 : UCIP\_SP\_2019\_53094\_38149.jpg

Comment Code						
Inspector Comment						
FS_ID:53094 DS_ID:23156 EP_NO: N/A Repair Type: Non-Urgent Crossing Status: Found UCIP Comments: 10/18/2018 Crossing remains abandoned. Unable to locate WS outlet due to dense vegetation. Crossing has been downgraded from Urgent to Non-Urgent. No integrity issues were observed along pipe alignment. LMA is still seeking proper abandonment or removal of this crossing. Crossing is part of the Deferred Maintenance Project (DMP) phase 1 inspection. No video inspection has been completed yet. (O. Magana - DWR UCIP) 11/18/2016 Same as last inspection this is a non-functional crossing with no visible inlet on LS or outlet on WS. The only appurtenance found at this location is a CMP riser with a missing cover located on the WS. This crossing remains Urgent since the pipe on the WS may still be opened. According to Mike Alves, this crossing is abandoned and the City of Modesto is working with CVFPB to authorize proper abandonment/removal. The City is working at finding funds to pay for proper abandonment/removal of all the drainage structures through this levee. (O. Magana - DWR UCIP)10/15/2013 Pipe open on WS and slide gate has been removed. Appears abandoned and should be done so properly. (W. Wylie - City of Modesto) FIELD_STRUCT_DESC: *ABANDONED* 24-inch corrugated metal drainage pipe through the levee, 9 feet below the crown. Slide gate in a corrugated metal pipe (CMP) riser located on the waterside (WS) slope. [Additional Reference(s): DWR Levee Log, 1992. USACE San Joaquin O&M Manual 6, September 1961, (HLM 0.10), Drawing No. 07-04-1555, Sheets 1555/17 and 1555/55, (Station 907+55)]. FS Date: 10/18/2018

Slide gate missing from open end of pipe at WS slope.

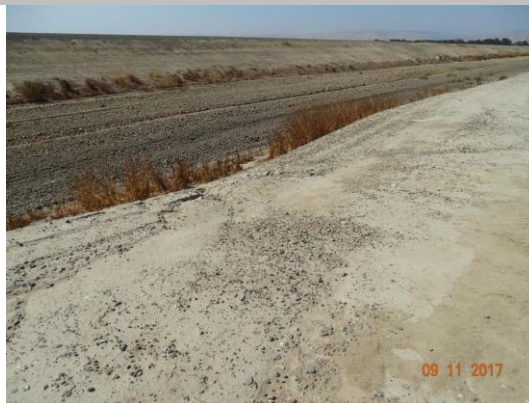
Photo 1 of 2 : SP\_2019\_RD2091\_318\_15\_20190307\_00014.jpg

LM Start	0.23	Rating **	A/W	Issue No.	15
LM End	0.23	Issue Type +	Ma	Location *	LS
Category	Earthen Levee			GPS Latitude/Longitude	
				Start	End
Item	Erosion / Bank Caving			37.541550 °	37.541550 °
				-121.096742 °	-121.096742 °
DWR ID	DWR_RD2091_01_s_2016_15				
Comment Code					
E1 : Note and monitor erosion site.					
Inspector Comment					
Caving on landward shoulder noted in 2017 possible collapsed pipe. Monitor for potential reoccurrence.

Looking southwest at the dip on the landside shoulder.

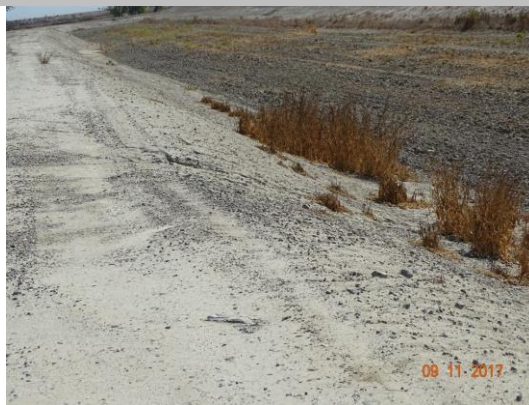
Photo 2 of 2 : SP\_2019\_RD2091\_318\_15\_20190307\_00015.jpg

Looking northeast at the dip in the landside shoulder.

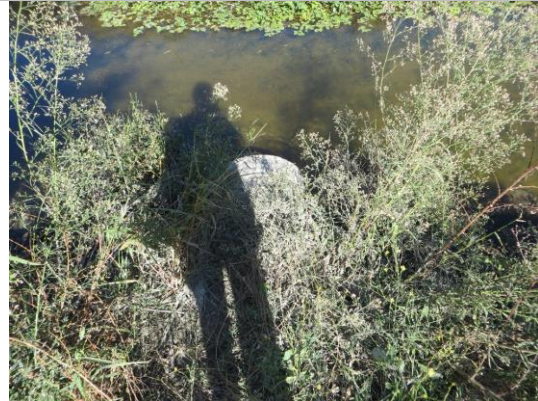
Photo 1 of 3 : UCIP\_SP\_2019\_53431\_38156.jpg

Comment Code					
Inspector Comment					
FS_ID:53431 DS_ID:23158 EP_NO: N/A Repair Type: Non-Urgent Crossing Status: Found UCIP Comments: 10/18/2018 Crossing remains abandoned. Unable to locate WS outlet due to dense vegetation. Crossing has been downgraded from Urgent to Non-Urgent, no integrity issues were observed along the pipe alignment. LMA is still seeking proper abandonment or removal of this crossing. This crossing is part of the Deferred Maintenance Project (DMP) phase 1 inspection. No video inspection has been completed yet. (O. Magana - DWR UCIP) 11/18/2016 Same as last inspection. This crossing remains Urgent due to the flap gate still missing from the WS toe. According to Mike Alves, this crossing is an abandoned line and the City of Modesto is working with CVFPB to authorize proper abandonment/removal. The City is working at finding funds to pay for proper abandonment/removal of all the drainage structures through this levee. (O. Magana - DWR UCIP) 10/15/2013 Flap gate has fallen off at WS toe. Appears abandoned and if so should be done so properly. (W. Wylie - DWR UCIP) FIELD_STRUCT_DESC: *ABANDONED* 24-inch corrugated metal drainage pipe through the levee, 10 feet below the crown. Flap gate on the waterside (WS) end. Drain opening is located approximately 15 feet off the landside (LS) toe. [Additional Reference(s): DWR Levee Log, 1992. USACE San Joaquin O&M Manual 6, September 1961, (HLM 0.23), Drawing No. 07-04-1555, Sheets 1555/17 and 1555/55, (Station 915+00)]. FS Date: 10/18/2018

Pipe visible in canal on WS toe.

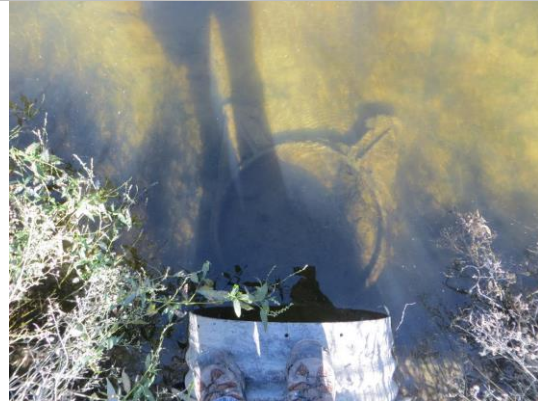
Photo 2 of 3 : UCIP\_SP\_2019\_53431\_38155.jpg

Comment Code						
Inspector Comment						
FS_ID:53431 DS_ID:23158 EP_NO: N/A Repair Type: Non-Urgent Crossing Status: Found UCIP Comments: 10/18/2018 Crossing remains abandoned. Unable to locate WS outlet due to dense vegetation. Crossing has been downgraded from Urgent to Non-Urgent, no integrity issues were observed along the pipe alignment. LMA is still seeking proper abandonment or removal of this crossing. This crossing is part of the Deferred Maintenance Project (DMP) phase 1 inspection. No video inspection has been completed yet. (O. Magana - DWR UCIP) 11/18/2016 Same as last inspection. This crossing remains Urgent due to the flap gate still missing from the WS toe. According to Mike Alves, this crossing is an abandoned line and the City of Modesto is working with CVFPB to authorize proper abandonment/removal. The City is working at finding funds to pay for proper abandonment/removal of all the drainage structures through this levee. (O. Magana - DWR UCIP) 10/15/2013 Flap gate has fallen off at WS toe. Appears abandoned and if so should be done so properly. (W. Wylie - DWR UCIP) FIELD_STRUCT_DESC: *ABANDONED* 24-inch corrugated metal drainage pipe through the levee, 10 feet below the crown. Flap gate on the waterside (WS) end. Drain opening is located approximately 15 feet off the landside (LS) toe. [Additional Reference(s): DWR Levee Log, 1992. USACE San Joaquin O&M Manual 6, September 1961, (HLM 0.23), Drawing No. 07-04-1555, Sheets 1555/17 and 1555/55, (Station 915+00)]. FS Date: 10/18/2018

Flapgate has fallen off at WS toe.

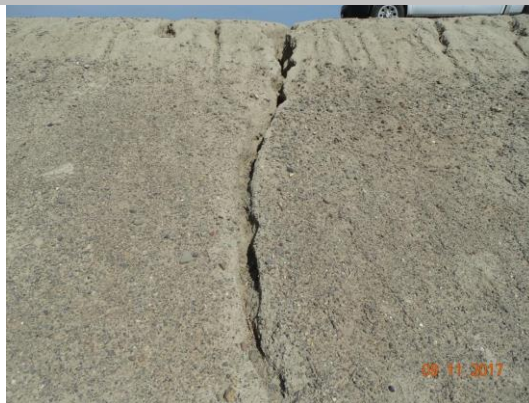
Photo 1 of 2 : SP\_2019\_RD2091\_318\_16\_20190307\_00016.jpg

Looking northwest at rill erosion on landside slope.

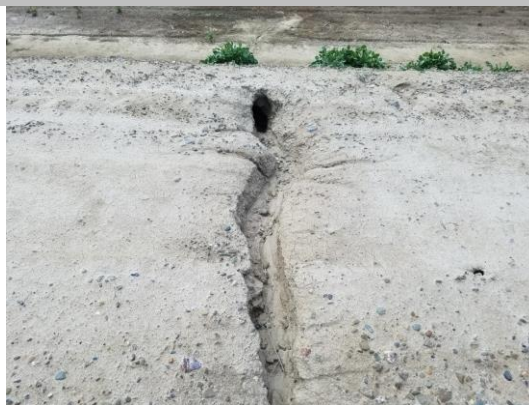
Photo 2 of 2 : SP\_2019\_RD2091\_318\_16\_20190307\_00017.jpg

Looking east at rill erosion above rodent hole on landward slope. (Spring 2017)

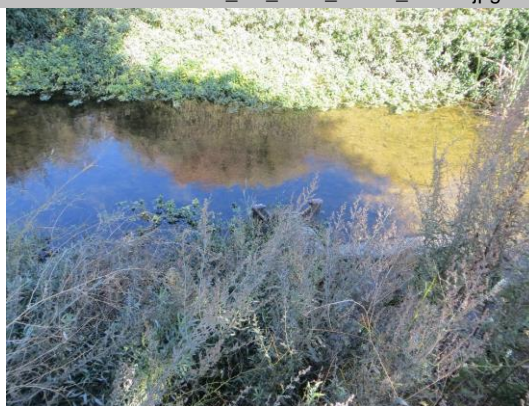
Photo 1 of 3 : UCIP\_SP\_2019\_51639\_38158.jpg

Comment Code						
Inspector Comment						
FS_ID:51639 DS_ID:23161 EP_NO: N/A Repair Type: Non-Urgent Crossing Status: Found UCIP Comments: 11/18/2016 Crossing has been downgraded from Urgent to Non-Urgent since the flap gate appears to fully close. According to Mike Alvez, this crossing is abandoned and the City of Modesto is working with CVFPB to authorize proper abandonment/removal. The City is working at finding funds to pay for proper abandonment/removal of all the drainage structures through this levee. (O. Magana - DWR UCIP)10/15/2013 Appears abandoned and if so should be done so properly. (W. Wylie - DWR UCIP) FIELD_STRUCT_DESC: *ABANDONED* 24-inch corrugated metal drainage pipe through the levee, 12 feet below the crown. Flap gate and concrete headwall on the waterside (WS) end. [Additional Reference(s): DWR Levee Log, 1992. USACE San Joaquin O&M Manual 6, September 1961, (HLM 0.64)]. FS Date: 11/18/2016

24-inch CMP on concrete headwall with flapgate on WS toe.

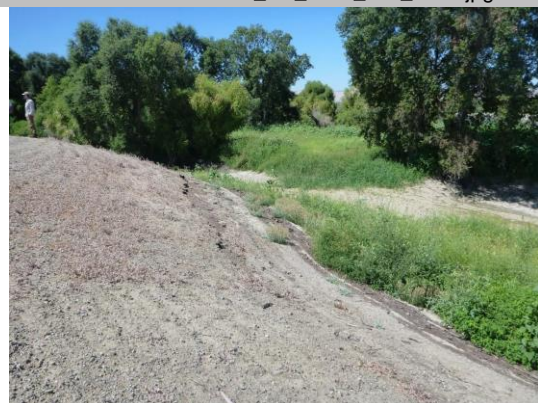
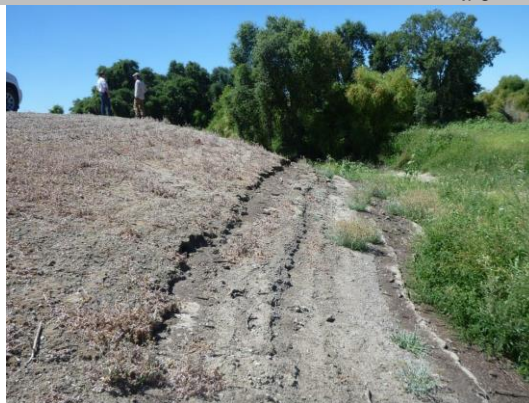
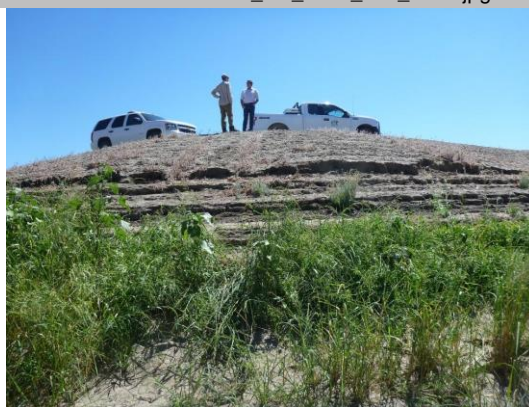
LM Start	0.94	Rating **	A/W	Issue No.	14
LM End	6.84	Issue Type +	Ma	Location *	
Category	Supplemental			GPS Latitude/Longitude	
				Start	End
Item	2017 Storm Damage			37.537775 °	37.482295 °
				-121.106730 °	-121.051592 °
DWR ID	DWR_RD2091_01_f _ 2017_14				
Comment Code					
Inspector Comment					
Levee Evaluation Comments					
Description:Wave wash damage/erosion of 2 miles ... see attached description and photos					
Site ID No:471					
Site Designation:LMA-298					
Repair Type: Erosion					
Rating:Area of Concern					
Field Date:7/20/2017					
Notes: Low priority because wavewash scarps are less than 1 ft and do not cut into prisim significantly and can be repaired by district through O&M. There is also a large berm here. Wavewash is present on both LS and WS

LM Start	0.94	Rating **	A/W	Issue No.	14 (cont)	
LM End	6.84	Issue Type +	Ma	Location *		
Category	Supplemental			GPS Latitude/Longitude		
				Start	End	
Item	2017 Storm Damage			37.537775 °	37.482295 °	
				-121.106730 °	-121.051592 °	
DWR ID	DWR_RD2091_01_f _ 2017_14					
Comment Code						
Inspector Comment						
Levee Evaluation Comments						
Description:Wave wash damage/erosion of 2 miles ... see attached description and photos						
Site ID No:471						
Site Designation:LMA-298						
Repair Type: Erosion						
Rating:Area of Concern						
Field Date:7/20/2017						
Notes: Low priority because wavewash scarps are less than 1 ft and do not cut into prisim significantly and can be repaired by district through O&M. There is also a large berm here. Wavewash is present on both LS and WS.

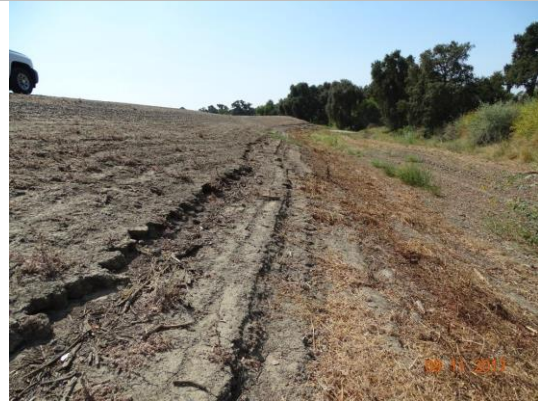
Photo 1 of 1 : SP\_2019\_RD2091\_318\_11\_20190307\_00007.jpg

LM Start	1.41	Rating **	A/W	Issue No.	11
LM End	1.43	Issue Type +	Ma	Location *	WS
Category	Earthen Levee			GPS Latitude/Longitude	
				Start	End
Item	Erosion / Bank Caving			37.531243 °	37.530896 °
				-121.106716 °	-121.106737 °
DWR ID	DWR_RD2091_01_f_2017_11				
Comment Code					
E2 : Schedule repair of erosion site prior to the next inspection.					
Inspector Comment					
Minor erosion on waterside toe.

Looking south at erosion on waterside slope. (Fall 2017)

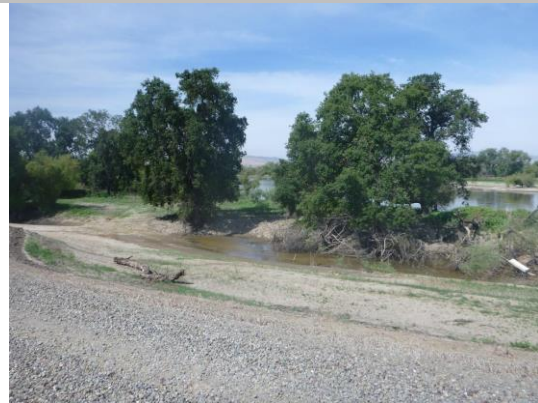
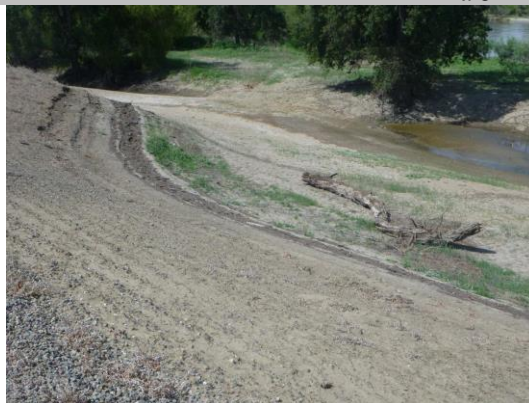
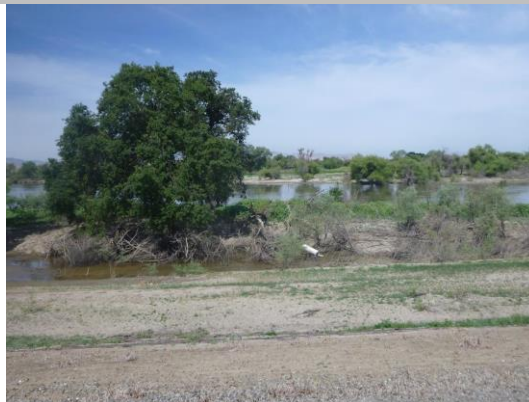
LM Start	1.41	Rating **	A/W	Issue No.	24
LM End	1.44	Issue Type +	Ma	Location *	
Category	Supplemental			GPS Latitude/Longitude	
				Start	End
Item	2017 Storm Damage			37.531170 °	37.530760 °
				-121.106750 °	-121.106710 °
DWR ID	DWR_RD2091_01_f_2017_24				
Comment Code					
Inspector Comment					
Levee Evaluation Comments					
Description:					
Site ID No:132					
Site Designation:DWR_RD2091_01_R_2012_01					
Repair Type: Erosion					
Rating:Area of Concern					
Field Date:6/7/2017					
Notes: Wavewash erosion up to 12" deep at high water mark.

LM Start	1.41	Rating **	A/W	Issue No.	24 (cont)	
LM End	1.44	Issue Type +	Ma	Location *		
Category	Supplemental			GPS Latitude/Longitude		
				Start	End	
Item	2017 Storm Damage			37.531170 °	37.530760 °	
				-121.106750 °	-121.106710 °	
DWR ID	DWR_RD2091_01_f_2017_24					
Comment Code						
Inspector Comment						
Levee Evaluation Comments						
Description:						
Site ID No:132						
Site Designation:DWR_RD2091_01_R_2012_01						
Repair Type: Erosion						
Rating:Area of Concern						
Field Date:6/7/2017						
Notes: Wavewash erosion up to 12" deep at high water mark.

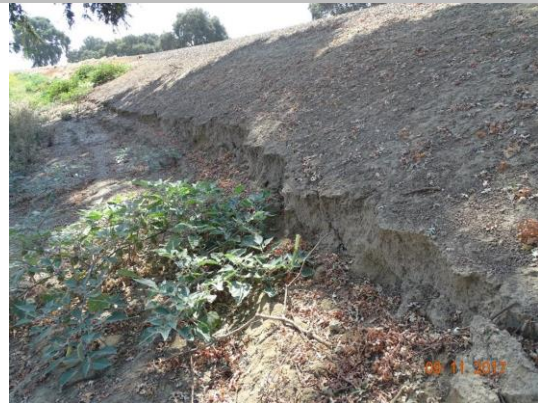
Photo 1 of 1 : SP\_2019\_RD2091\_318\_18\_20190307\_00018.jpg

LM Start	2.05	Rating **	M	Issue No.	18
LM End	2.06	Issue Type +	Ma	Location *	LS
Category	Earthen Levee			GPS Latitude/Longitude	
				Start	End
Item	Erosion / Bank Caving			37.526083 °	37.525897 °
				-121.099328 °	-121.099116 °
DWR ID	DWR_RD2091_01_f_2017_18				
Comment Code					
E2 : Schedule repair of erosion site prior to the next inspection.					
Inspector Comment					
Erosion at the landside toe.

Looking southeast at erosion on the toe of the landside slope.

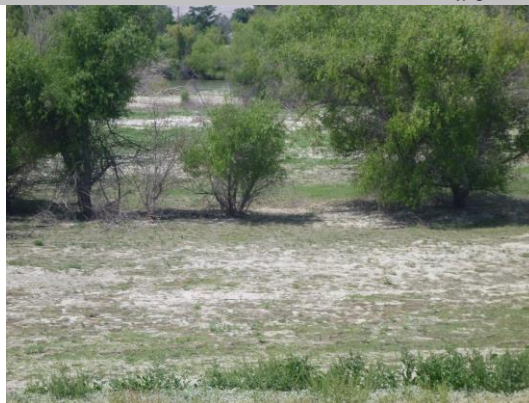
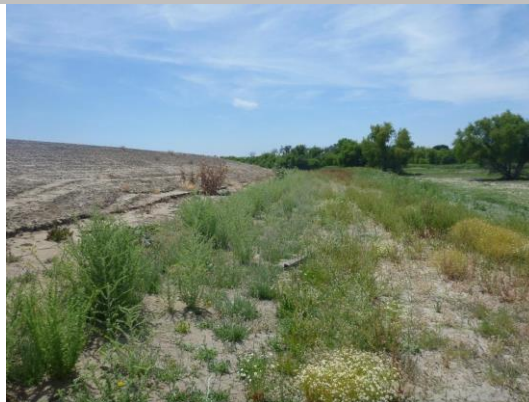
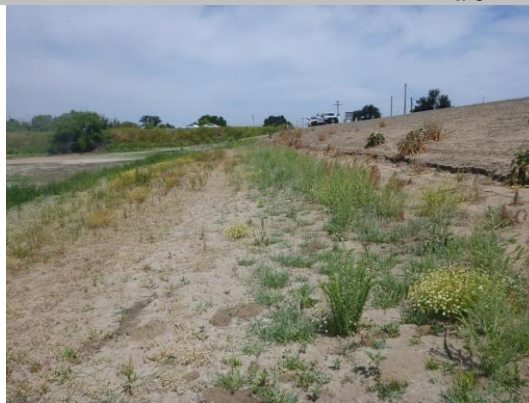
LM Start	4.83	Rating **	A/W	Issue No.	41	
LM End	4.83	Issue Type +	Ma	Location *		
Category	Supplemental			GPS Latitude/Longitude		
				Start	End	
Item	2017 Storm Damage			37.494300 °	37.494300 °	
				-121.078300 °	-121.078300 °	
DWR ID	DWR_RD2091_01_f_2017_41					
Comment Code						
Inspector Comment						
Levee Evaluation Comments						
Description:						
Site ID No:117						
Site Designation:LMA-37						
Repair Type: Erosion						
Rating:Area of Concern						
Field Date:6/7/2017						
Notes: Very minor erosion at toe of levee. Depth of erosion is 3" max.

LM Start	4.83	Rating **	A/W	Issue No.	41 (cont)	
LM End	4.83	Issue Type +	Ma	Location *		
Category	Supplemental			GPS Latitude/Longitude		
				Start	End	
Item	2017 Storm Damage			37.494300 °	37.494300 °	
				-121.078300 °	-121.078300 °	
DWR ID	DWR_RD2091_01_f_2017_41					
Comment Code						
Inspector Comment						
Levee Evaluation Comments						
Description:						
Site ID No:117						
Site Designation:LMA-37						
Repair Type: Erosion						
Rating:Area of Concern						
Field Date:6/7/2017						
Notes: Very minor erosion at toe of levee. Depth of erosion is 3" max.

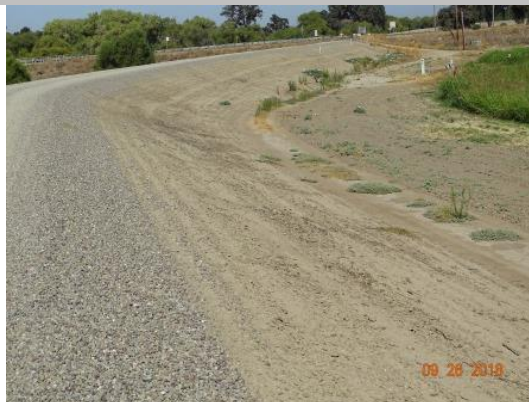
Photo 1 of 3 : SP\_2019\_RD2091\_318\_10\_20190307\_00004.jpg

LM Start	4.84	Rating **	A/W	Issue No.	10
LM End	4.85	Issue Type +	Ma	Location *	LS
Category	Earthen Levee			GPS Latitude/Longitude	
				Start	End
Item	Animal Control			37.494297 °	37.494115 °
				-121.078233 °	-121.078100 °
DWR ID	DWR_RD2091_01_f_2018_10				
Comment Code					
A3 : No rodents visible, but rodent burrows visible; need to backfill and compact or grout burrows.					
Inspector Comment					
No visible burrows and rodent control program visible. (2018)

View of landside slope. (2018)

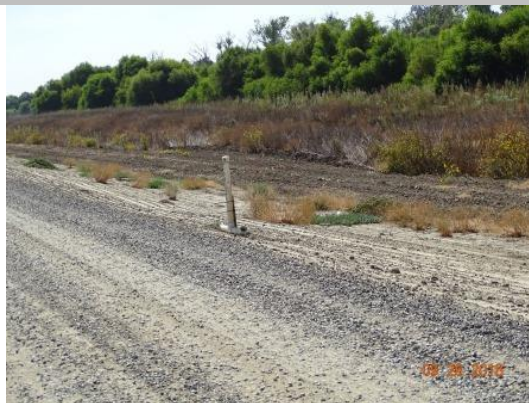
Photo 2 of 3 : SP\_2019\_RD2091\_318\_10\_20190307\_00005.jpg

View of rodent control program in place. (2018)

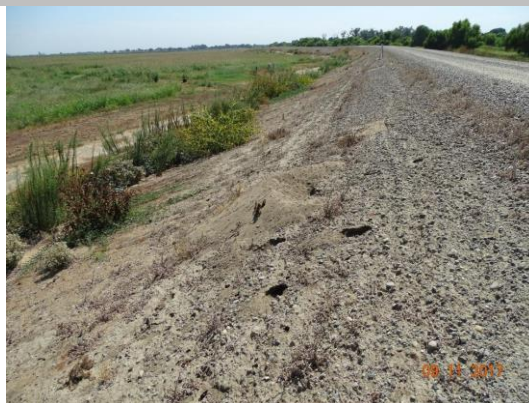
Photo 3 of 3 : SP\_2019\_RD2091\_318\_10\_20190307\_00006.jpg

Looking southeast at landside slope. (2017)

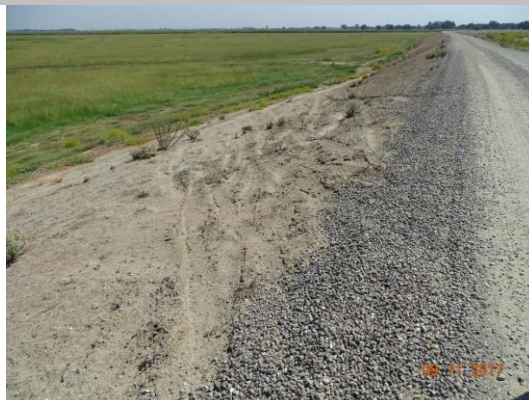
Photo 1 of 2 : SP\_2019\_RD2091\_318\_13\_20190307\_00009.jpg

LM Start	5.20	Rating **	A/W	Issue No.	13
LM End	5.20	Issue Type +	Ma	Location *	LS
Category	Earthen Levee			GPS Latitude/Longitude	
				Start	End
Item	Slope Stability			37.490756 °	37.490756 °
				-121.073410 °	-121.073410 °
DWR ID	DWR_RD2091_01_f_2016_13				
Comment Code					
S3 : Repair the levee slope damaged by vehicle traffic and prevent access where possible.					
Inspector Comment					
Vehicle traffic damaging slope on landward slope.

Looking southeast at the landside slope.

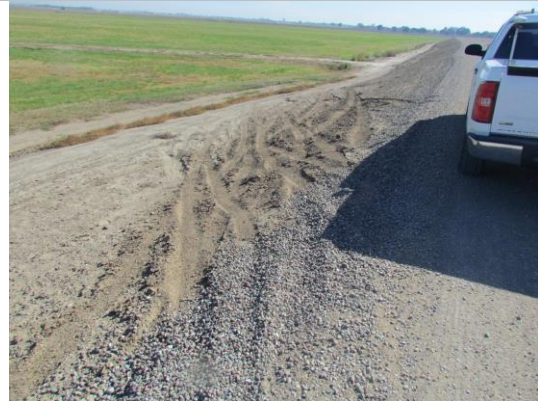
Photo 2 of 2 : SP\_2019\_RD2091\_318\_13\_20190307\_00010.jpg

LM Start	5.20	Rating **	A/W	Issue No.	13 (cont)	
LM End	5.20	Issue Type +	Ma	Location *	LS	
Category	Earthen Levee			GPS Latitude/Longitude		
				Start	End	
Item	Slope Stability			37.490756 °	37.490756 °	
				-121.073410 °	-121.073410 °	
DWR ID	DWR_RD2091_01_f_2016_13					
Comment Code						
S3 : Repair the levee slope damaged by vehicle traffic and prevent access where possible.						
Inspector Comment						
Vehicle traffic damaging slope on landward slope.

Looking at damage on landside slope.

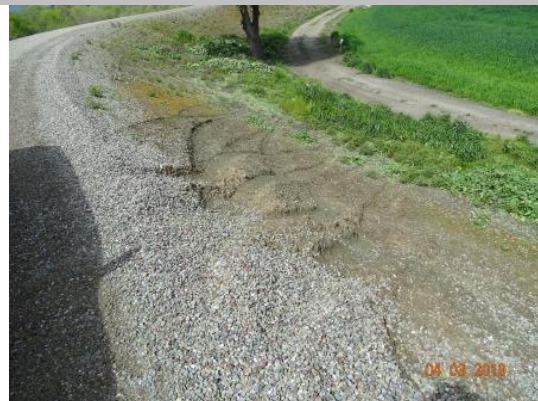
Photo 1 of 1 : SP\_2019\_RD2091\_318\_21\_20190404\_00046.jpg

LM Start	5.74	Rating **	M	Issue No.	21
LM End	5.74	Issue Type +	Ma	Location *	LS
Category	Earthen Levee			GPS Latitude/Longitude	
				Start	End
Item	Slope Stability			37.485318 °	37.485318 °
				-121.066454 °	-121.066454 °
DWR ID	DWR_RD2091_01_s_2019_21				
Comment Code					
S3 : Repair the levee slope damaged by vehicle traffic and prevent access where possible.					
Inspector Comment					
Vehicle damage to landside slope.

View of damage to landside slope looking downstream. (Spring 2019)

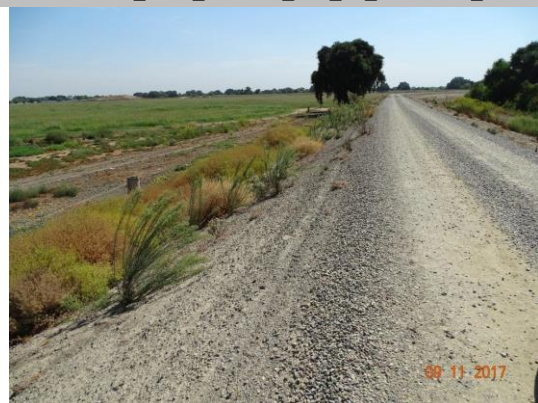
Photo 1 of 1 : SP\_2019\_RD2091\_318\_36\_20190307\_00027.jpg

Looking southeast at landside slope.

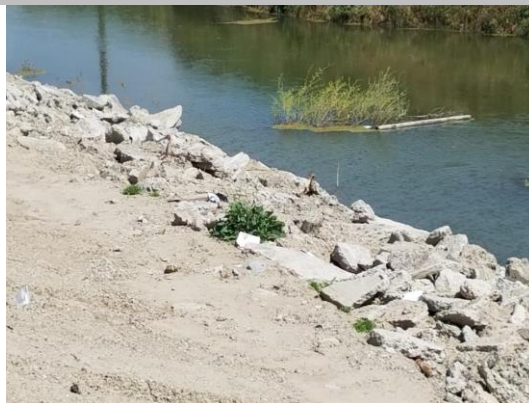
Photo 1 of 3 : SP\_2019\_RD2091\_318\_8\_20190307\_00001.jpg

LM Start	7.42	Rating **	U	Issue No.	8
LM End	7.45	Issue Type +	Ma	Location *	LS
Category	Earthen Levee			GPS Latitude/Longitude	
				Start	End
Item	Erosion / Bank Caving			37.479308 °	37.478998 °
				-121.044708 °	-121.044660 °
DWR ID	DWR_RD2091_01_s_2017_8				
Comment Code					
E2 : Schedule repair of erosion site prior to the next inspection.					
Inspector Comment					
Repaired area with concrete containing rebar. Need to remove rebar.

Looking northeast at concrete rubble with rebar at landward toe next to canal.

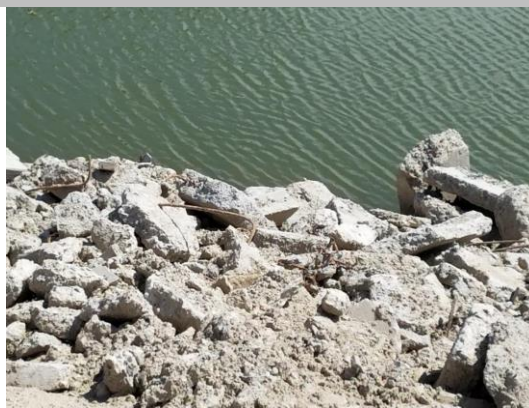
Photo 2 of 3 : SP\_2019\_RD2091\_318\_8\_20190307\_00002.jpg

Looking east at concrete rubble with rebar at landward toe next to canal.

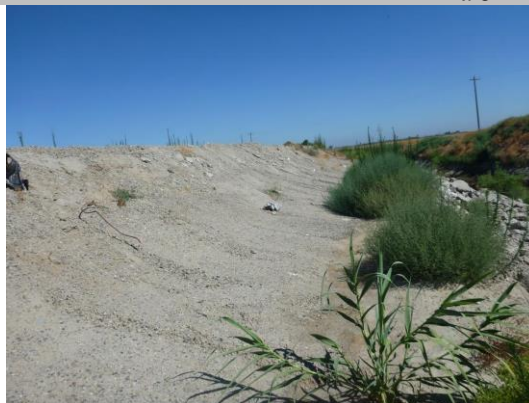
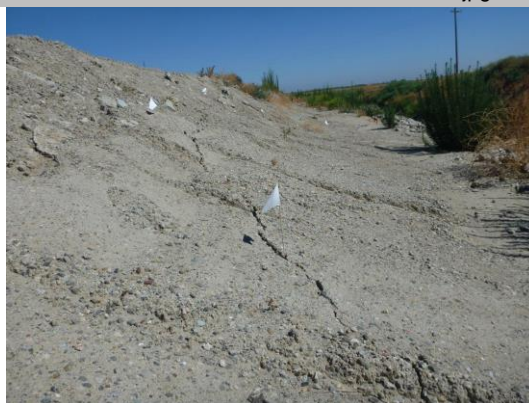
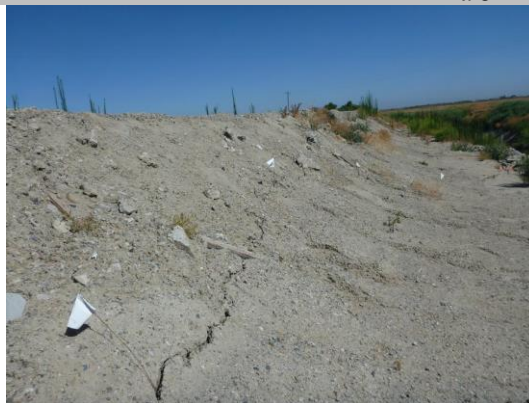
LM Start	7.45	Rating **	A/W	Issue No.	23
LM End	7.45	Issue Type +	Ma	Location *	
Category	Supplemental			GPS Latitude/Longitude	
				Start	End
Item	2017 Storm Damage			37.479000 °	37.479000 °
				-121.044000 °	-121.040000 °
DWR ID	DWR_RD2091_01_f_2017_23				
Comment Code					
Inspector Comment					
Levee Evaluation Comments					
Description:Sloughing at Mile 7.59 of the San Joaquin River					
Site ID No:473					
Site Designation:LMA-300					
Repair Type: Erosion					
Rating:Area of Concern					
Field Date:7/20/2017					
Notes: Concrete rubble was installed here during the storms after noticing cracks and sloughing. It has rebar sticking out and needs to be replaced with clean rip rap. Responsibility is grey here because TID maintains channel and placed concrete during storm.

LM Start	7.45	Rating **	A/W	Issue No.	23 (cont)	
LM End	7.45	Issue Type +	Ma	Location *		
Category	Supplemental			GPS Latitude/Longitude		
				Start	End	
Item	2017 Storm Damage			37.479000 °	37.479000 °	
				-121.044000 °	-121.044000 °	
DWR ID	DWR_RD2091_01_f_2017_23					
Comment Code						
Inspector Comment						
Levee Evaluation Comments						
Description:Sloughing at Mile 7.59 of the San Joaquin River						
Site ID No:473						
Site Designation:LMA-300						
Repair Type: Erosion						
Rating:Area of Concern						
Field Date:7/20/2017						
Notes: Concrete rubble was installed here during the storms after noticing cracks and sloughing. It has rebar sticking out and needs to be replaced with clean rip rap. Responsibility is grey here because TID maintains channel and placed concrete during storm.

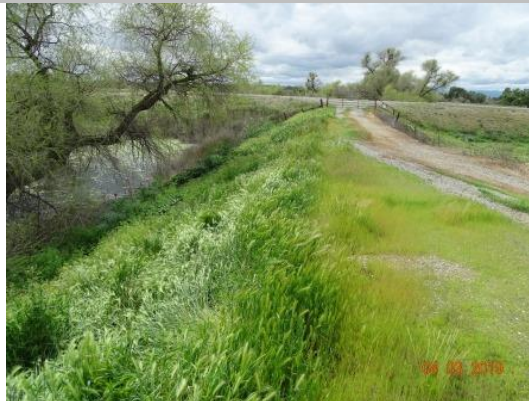
Photo 1 of 1 : SP\_2019\_RD2091\_319\_2\_20190404\_00004.jpg

View of waterside slope looking downstream. (Spring 2019)
